MEMORANDUM

From: LCDR Chris van Westendorp, NOAA, Staff, Atlantic Hydrographic Branch

Subj: Trip Report for Gulf of Honduras Project Phase 2 Hydrographic Training Mission to Belize

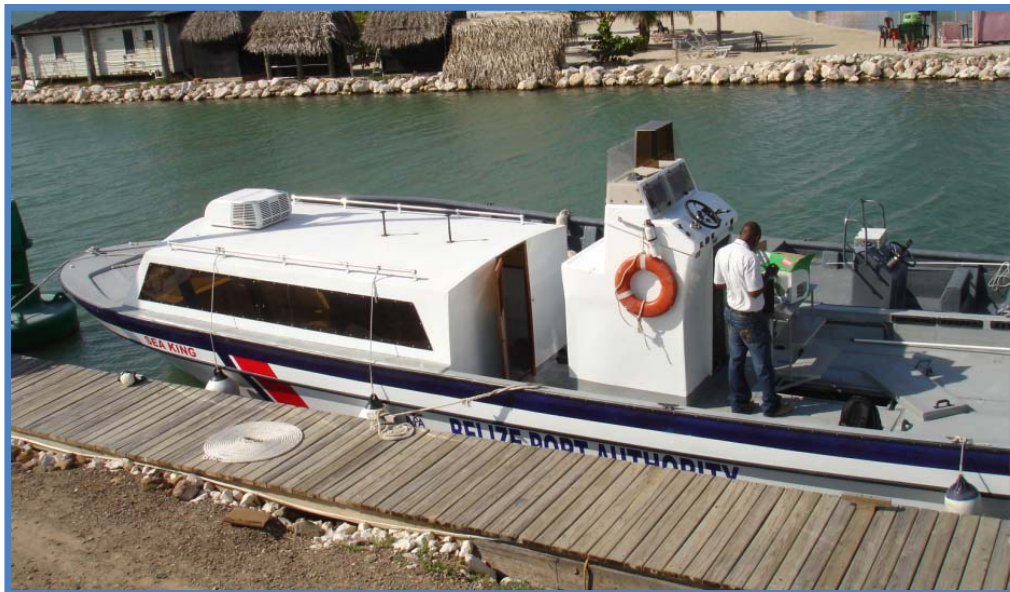
4. **R/V SEA KING** – One of the major hindrances during the 2009 training period stemmed from the fact that BPA’s designated survey vessel (R/V SEA KING) was not ready for sea due to much-needed engine overhaul and power/cabin modifications. SEA KING became available for survey during the spring & summer of 2009 and has been used for preliminary and/or reconnaissance hydrographic surveys since then. While the vessel’s two engines are diesel, its generator is a separate gasoline-powered 50Hz/120V Onan. Modifications to the vessel’s original design included an improved cabin superstructure complete with air conditioning, providing shelter for survey personnel and hydrographic survey equipment preservation.

BPA Hydrographic Survey Vessel – R/V SEA KING at Old Belize

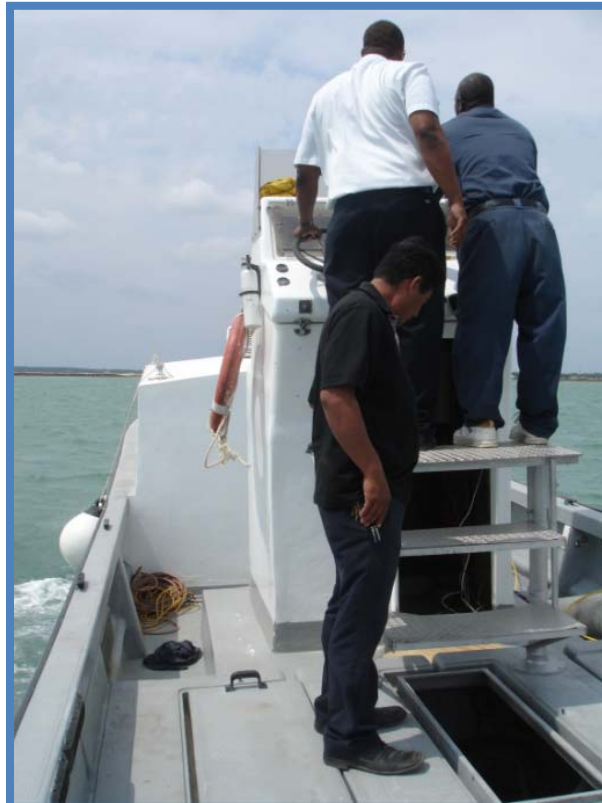
5. **Vessel Safety Issues** – The following safety hazards were identified on SEA KING during Phase 2 training:
 - a. SEA KING has very few hand railings, most importantly around the exterior of the vessel and coxswain stand. It is highly recommended that hand railings be installed inside and around the vessel to provide critical safety support for crewmembers. Additionally, it is recommended that a windowed shelter be constructed around the coxswain stand to protect the coxswain/captain and provide shading for increased visibility of the survey display.

Safety Railings: The lack of hand railings onboard SEA KING present a serious safety hazard to crew members, particularly the coxswain/captain, who has no lateral or aft railing support while standing at a high point in the vessel's reference frame.

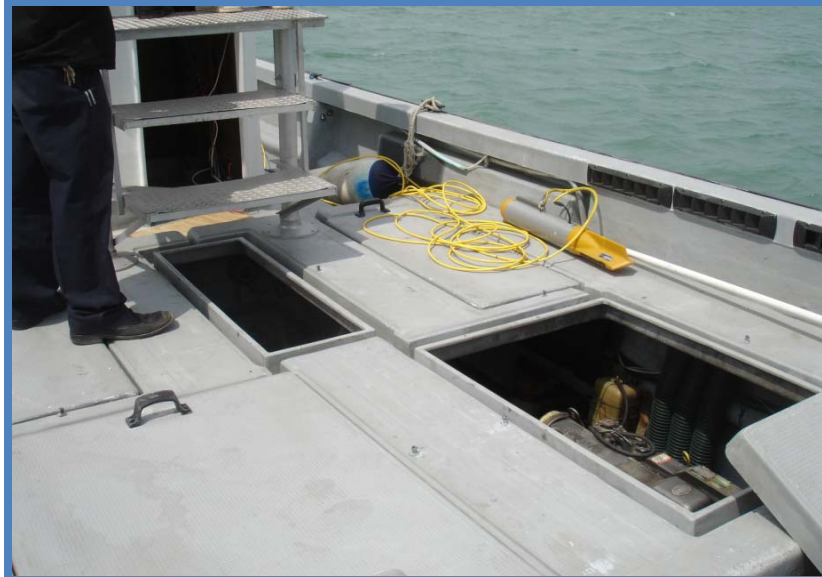
- b. As SEA KING uses diesel (propulsion engines) as well as gasoline (electric generator), BPA personnel are concerned about fume mixing and the potential for fire due to unseen leaks and engine compartment overheating. This concern is compounded by the fact that there is no working internal ventilation system in the engine compartment. BPA personnel address this issue by removing at least one compartment cover during at-sea operations to promote natural air ventilation. This presents a significant safety hazard to crewmembers due to risks of tripping, falling, burns, or more serious injuries. Therefore, it is recommended that a forced air ventilation system be procured and installed in the SEA KING engine compartment.

Compartment Covers are removed from the engine compartment during at-sea operations in order to provide natural air ventilation for the propulsion engines and generator; this poses a significant safety hazard.

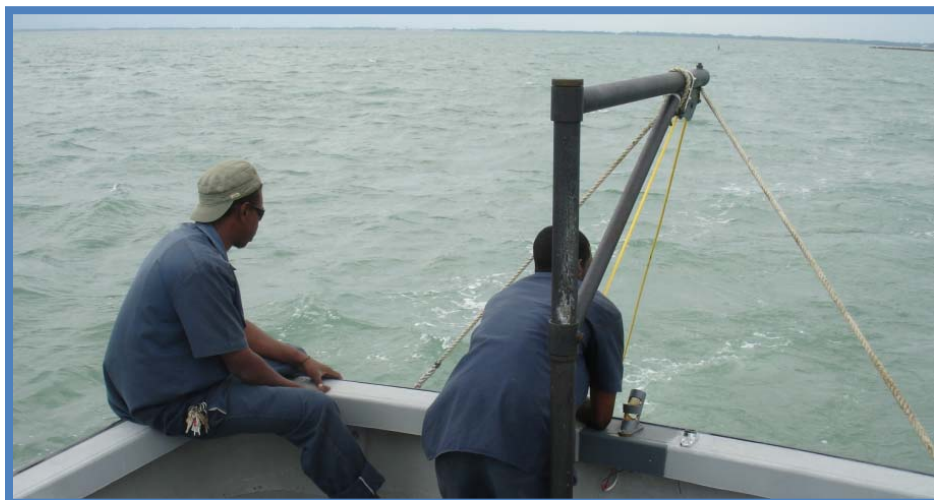
- c. The side scan sonar is towed from an aft centerline towpoint on the vessel. In order to maintain positive control of the towfish and rapidly adjust cable out with changes in towfish altitude, one BPA crewmember must maintain a continuous watch on the towcable and haul in / let out cable by hand as necessary. This poses a safety issue to the cable watch, particularly with regard to a trip hazard from the deck-lain towcable and a finger snag hazard from the towpoint block/pulley. It is recommended that an electric winch with 100m of cable be procured and installed on the vessel for towed side scan sonar operations.

Side Scan Towpoint: The side scan tow cable must be hand tended, introducing safety hazards to the cable watchperson.

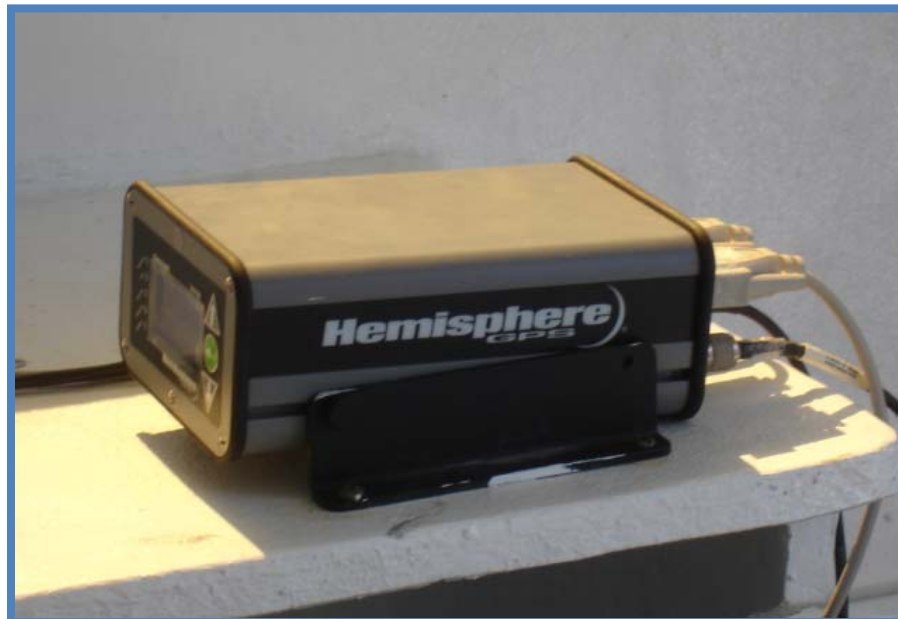
- g. **HemisphereGPS Crescent VS-100** – The GPS operated properly throughout the Phase 2 training period. However, the receiver unit is currently mounted inside the cabin in a relatively unstable manner. The unit should be held inside the vendor-provided mounting brackets with four (4) mounting screws, whereas it is currently held in place with only two (2) screws. This mounting method may result in unreliable GPS positioning and/or heading/pitch measurement. It is recommended that the GPS be mounted with four (4) screws per the VS-100 operating manual.

GPS Receiver Unit: The Crescent VS-100 GPS receiver is currently held in place in its mounting brackets with only two (2) screws rather than four (4) screws as stated in the operating manual.
