CIO+ StayAway

Detecting hidden Shoals from Space

ChartWorld
Group

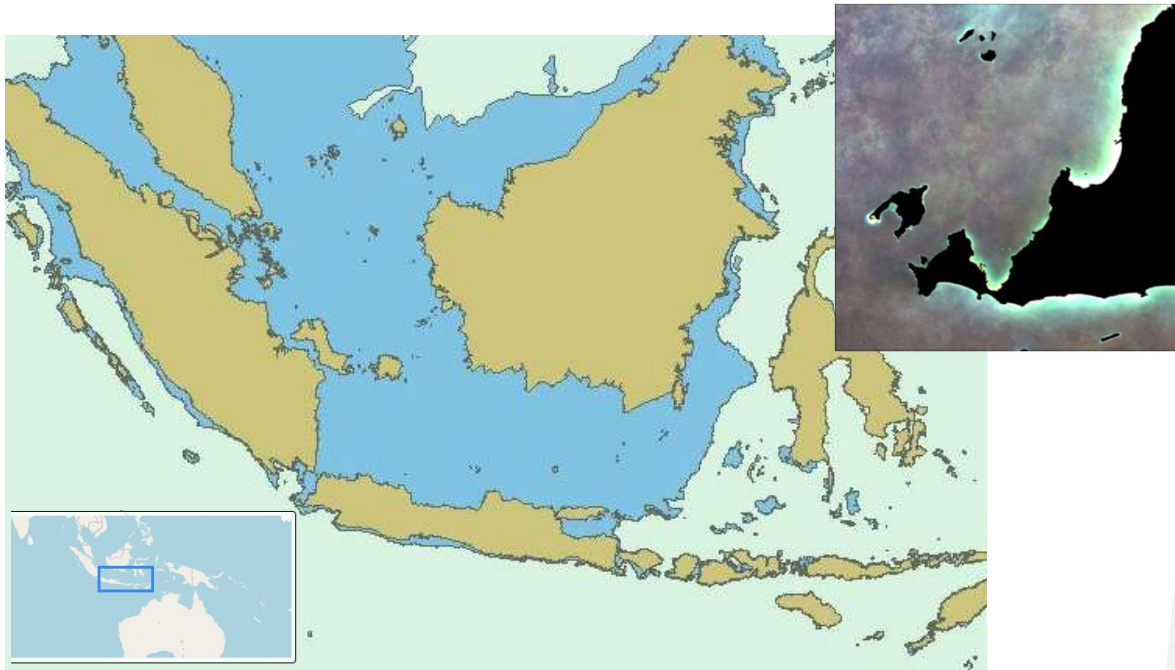
Indonesian archipelago serves as test area

Selection of suitable multispectral satellite imagery of the area

Processing of satellite images to identify obstructions

Vectorize identified obstructions and create StayAway features

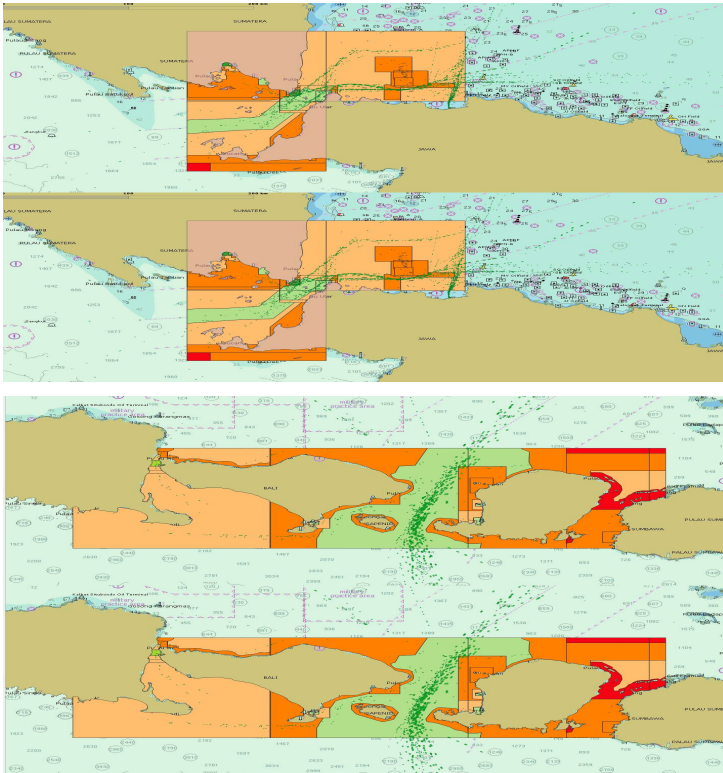
In total we reviewed 10 tiles of 1 x 1 degree.

CIO+ StayAway indicates **shallower than surrounding areas in a depth from 10-30 meters**

4.724 shoal areas were detected in satellite data

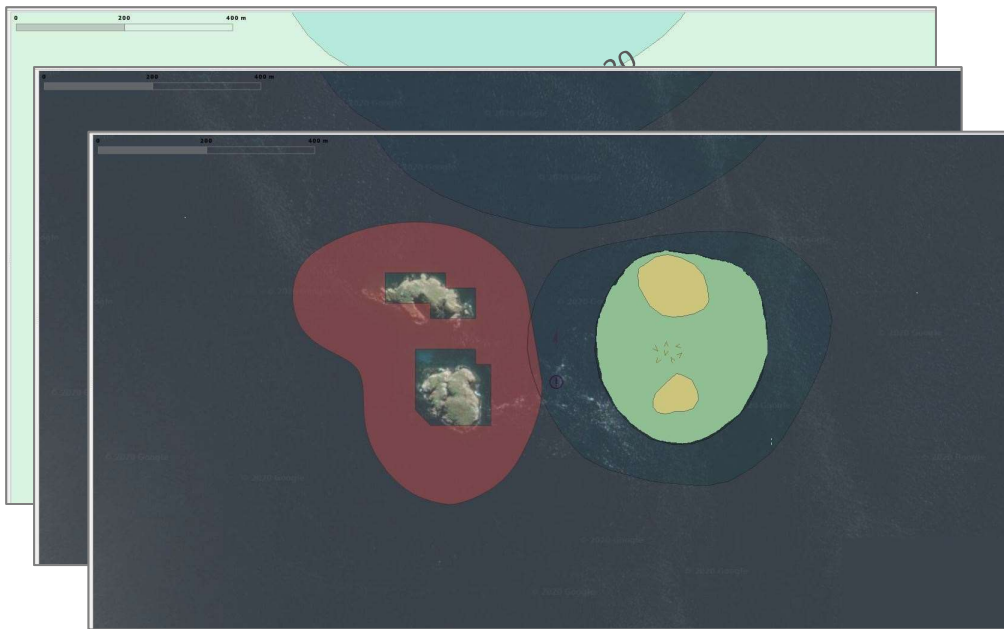
- Shallower than surrounding area
- No corresponding obstructions in ENC

In this example StayAway Areas are indicated where the satellite imagery is different to the position indicated on the corresponding ENC.

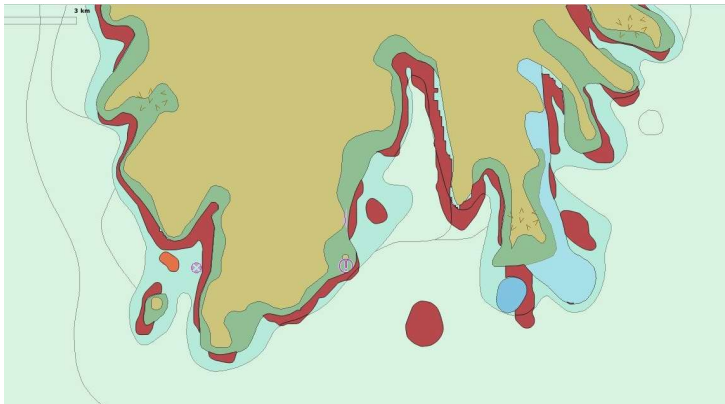
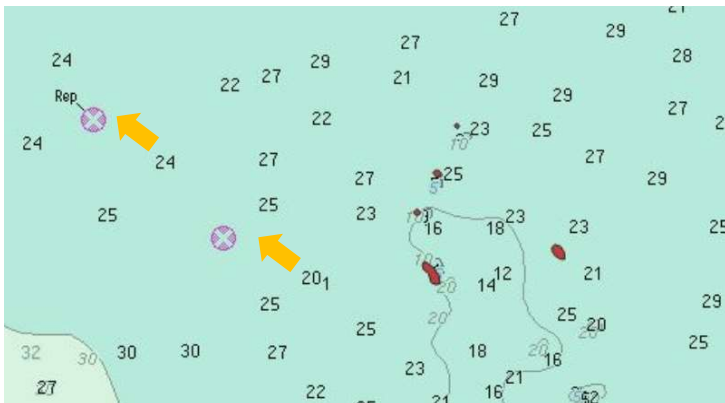
Depth value	Amount of obstructions shown in ENCs
> 20m	18
< 20m	14
unknown	349
Total	381

Of **381** isolated dangers in ENCs only

92 could be matched.

The remaining **289** isolated dangers are potentially at another location.

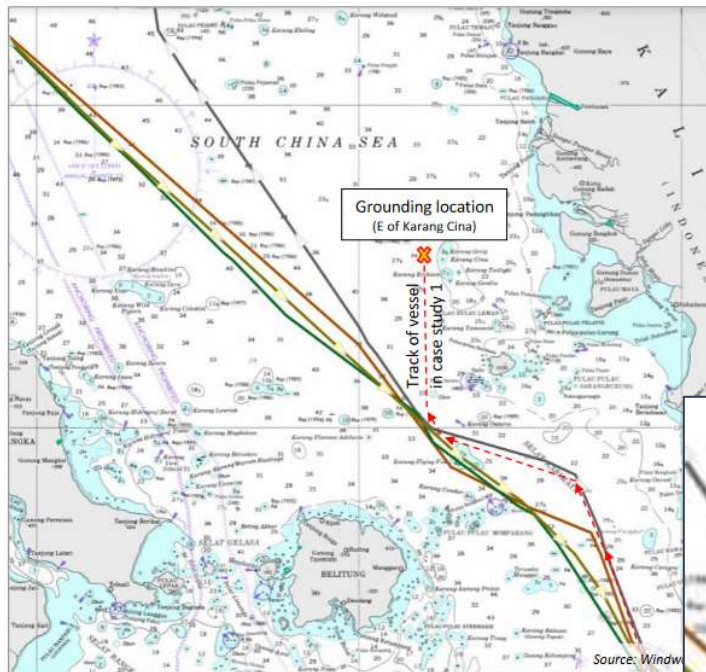
- Year:
- Vessel: Bulk Carrier
- Draft: 13 m
- Voyage: Indonesia to Japan via Karimata Strait
