## Libya, Darnah – assessment of hazards and changes against British Admiralty charts

Assessment date 20<sup>th</sup> September 2023

All assessment against raster chart BA3401 Panel A (Darnah), Edition Number 3, edition date 26 Oct 2017

Produced by UKHO Remote Sensing Section

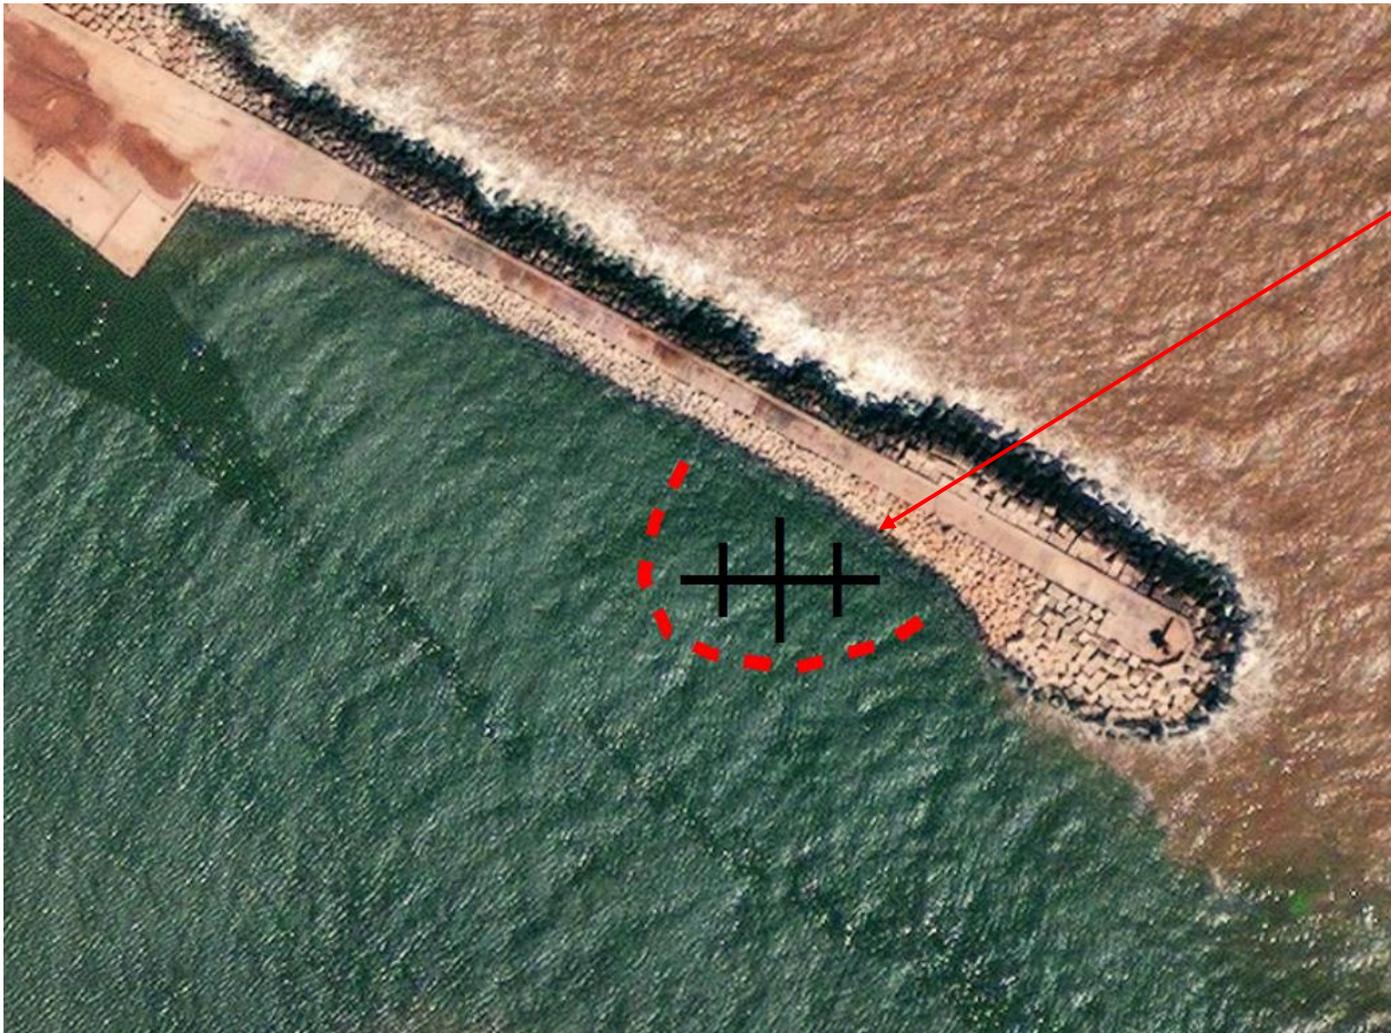
Northerly starboard breakwater

Historic uncharted  
submerged wreck in  
marked position  
LOA approx. 25m  
32 45.768N 22 39.473E

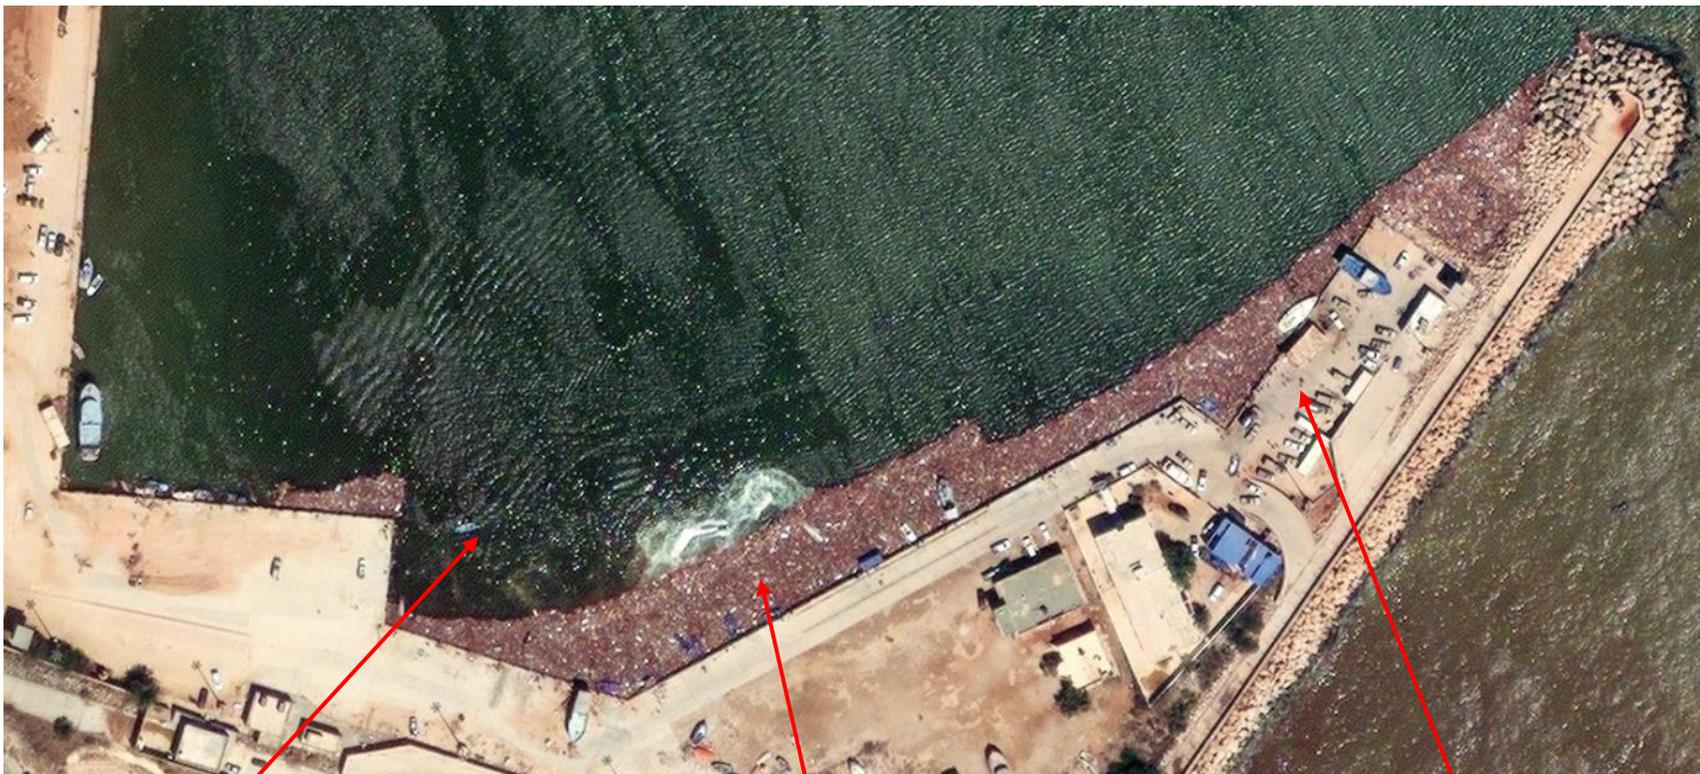
Southerly port breakwater

No longer accommodates the grain berth, as charted.

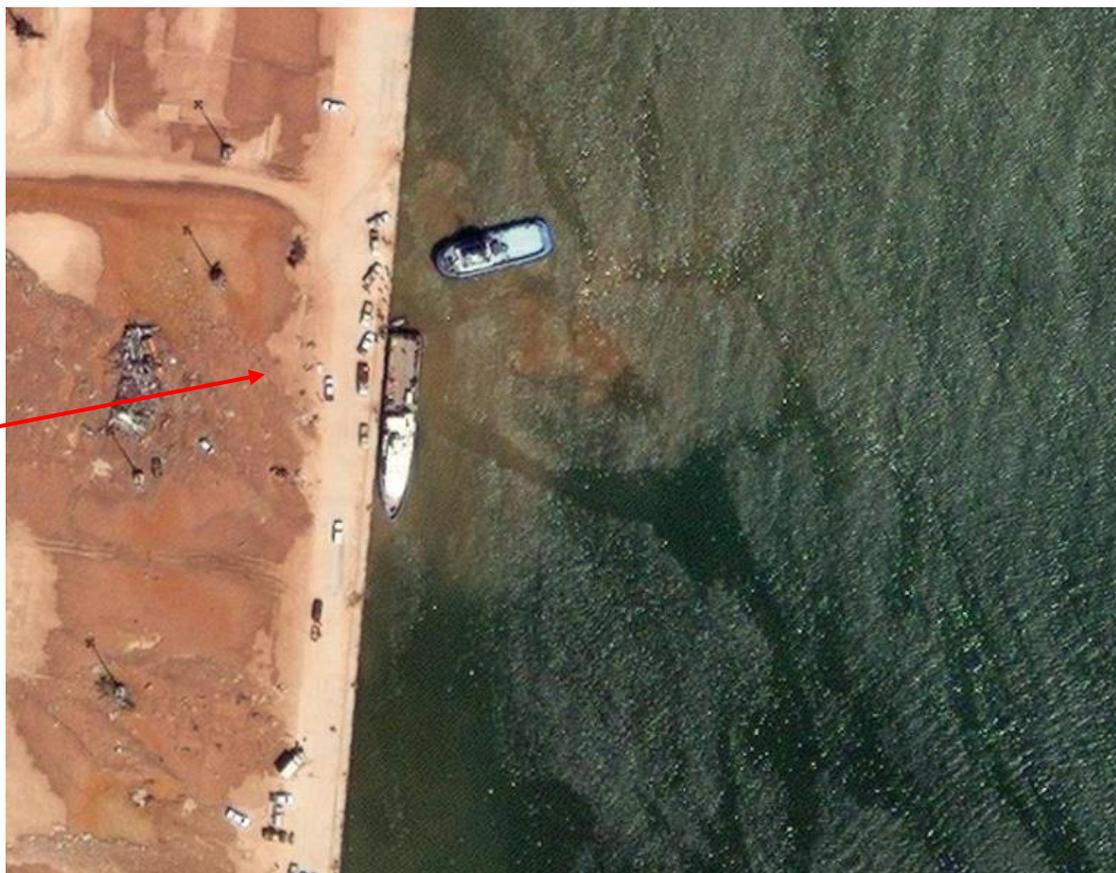
**Container Terminal & General Cargo, Berths No.2 & No.3**

Much sediment, mud and debris near the quayside with discolouration of water suggesting material has been swept into the water alongside the wharf that is berths 2 & 3. On 15<sup>th</sup> September, a naval vessel of 50m along with other vessels of 43m & 33m LOA were seen alongside. Suspended sediment is persistent in other images that do not show vessel movements.

Position at arrowhead:  
32 45.758N 22 39.167E

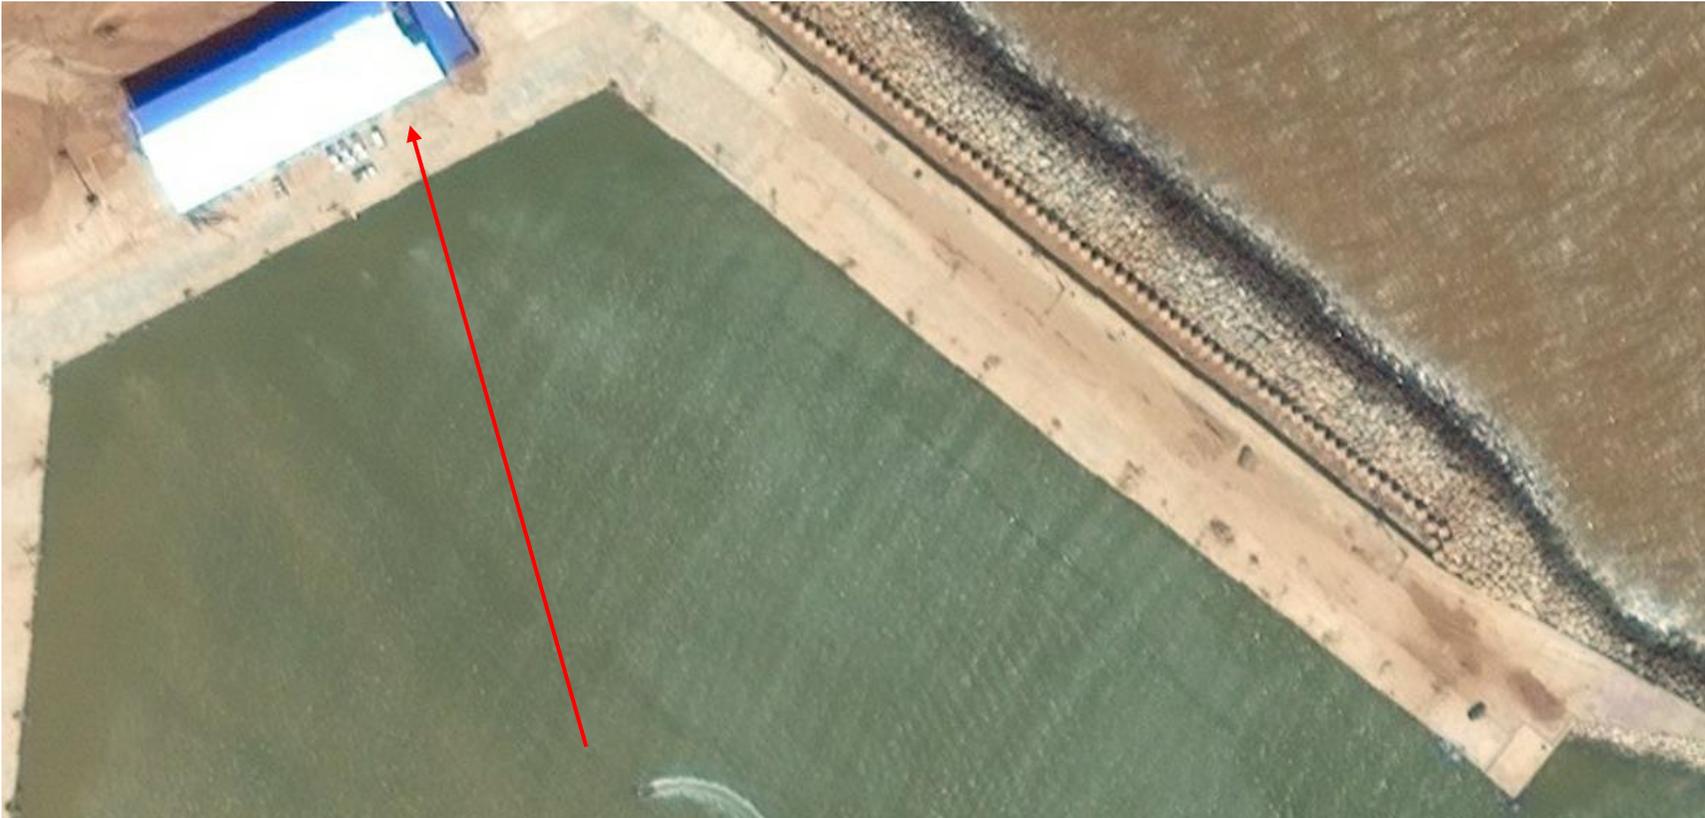
**North Quay & Berth No.1**

North quay berth and No.1 berth do not have visible evidence of obstructions. An offshore supply type vessel of 67m LOA has been noted alongside North Quay on 15<sup>th</sup> September along with many other smaller vessels.

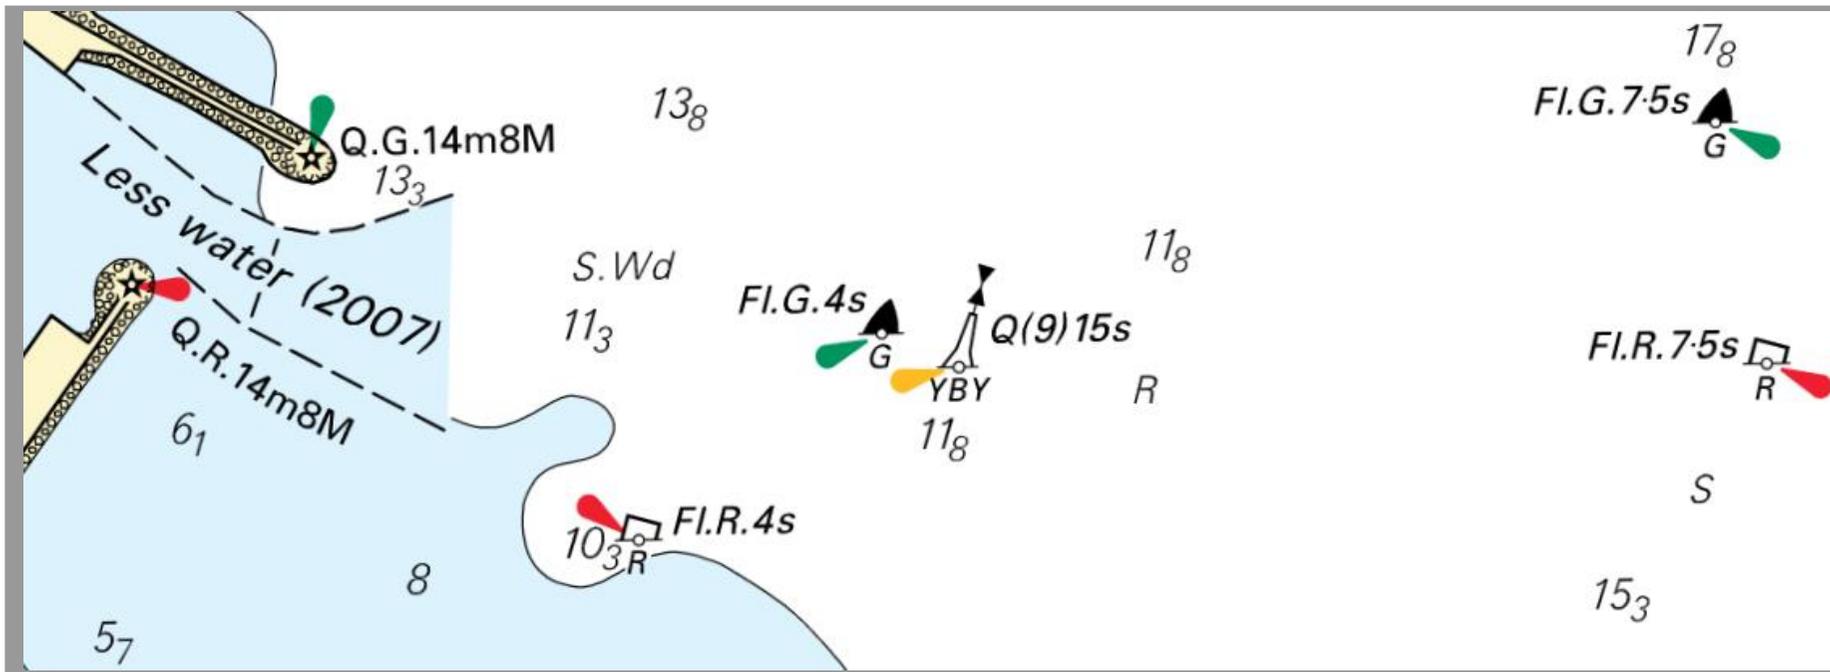
Aids to Navigation

Of the charted aids, only the lights on the breakwaters (port and starboard) are seen. None of the charted buoys are seen in imagery either before the event (1<sup>st</sup> July 2023) or after the event.

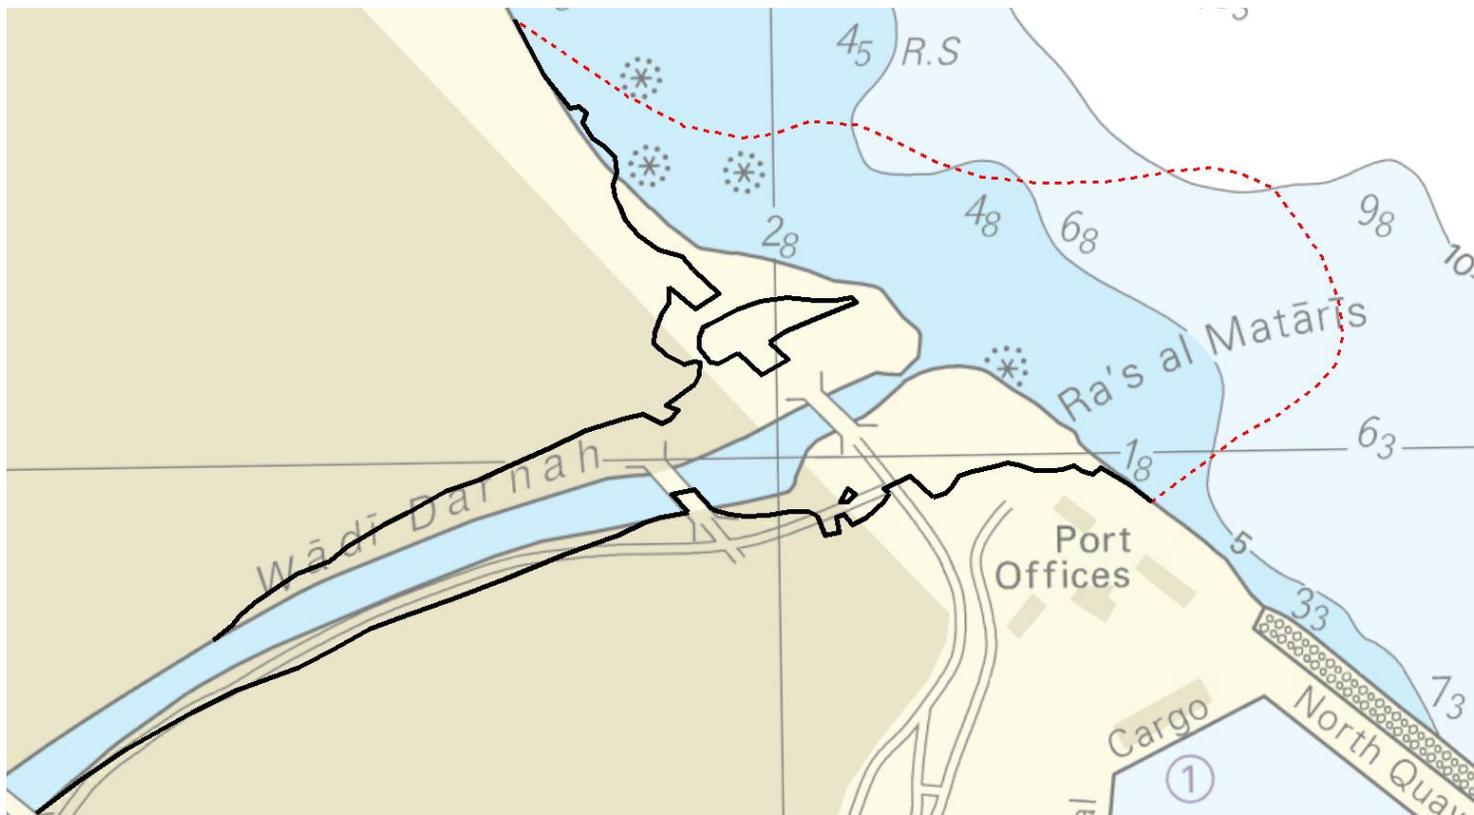
### Mouth of Wadi Darnah

There is significant coastline change around the mouth of Wadi Darnah. The new coast alignment is shown in black overlaid the chart. Much material has been deposited on the seabed to seaward, leading to an expected shoaling of the charted soundings. Where evidence for this exists, shoaling has been delineated by the red dashed line.

\*NOTE\* Due to the rough sea conditions and turbid water where the seabed is not visible, dangers and shoal water may exist to seaward of the red dashed line. This is for information only and extreme caution must be exercised. NOT TO BE USED FOR NAVIGATION.
