FINAL FIELD REPORT

2018 NEARSHORE
ST. LAWRENCE RIVER SURVEY

CHSDIR Project Number: 4800094
File Number: 4902210

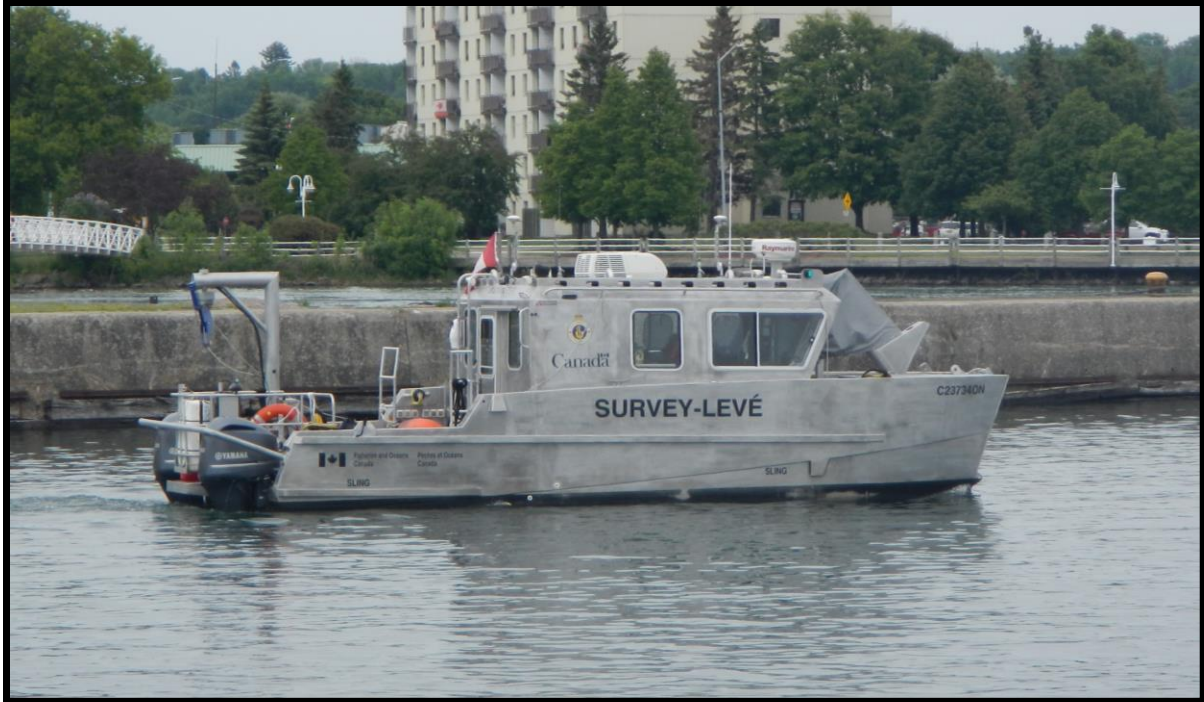
Figure 3 – CSL Bockmaster, Sault Canal (photo by A. Leyzack)

PLATFORM	HYDROGRAPHIC CAPACITY
<p><i>CSL Bockmaster</i> 8.9m, Hydrographic (Catamaran) Launch by Kanter Marine</p>	<ul style="list-style-type: none"> • Kongsberg EM2040C (Compact), hull-mounted Shallow Water (200-400kHz) Multibeam Sonar System. • Kongsberg Seafloor Information System (SIS) 4.3.2 for sonar interface, navigation and data logging. • Applanix POS/MV V5 Positioning System with Zephyr II GNSS antennae. • Applied Micro Systems Limited (AML) MVP 30 Moving Vessel Profile System augmented with Micro SV (surface sound speed sensor) and AML Minos sound velocity probes. • <i>Petite Ponar</i> sediment grab sampler.

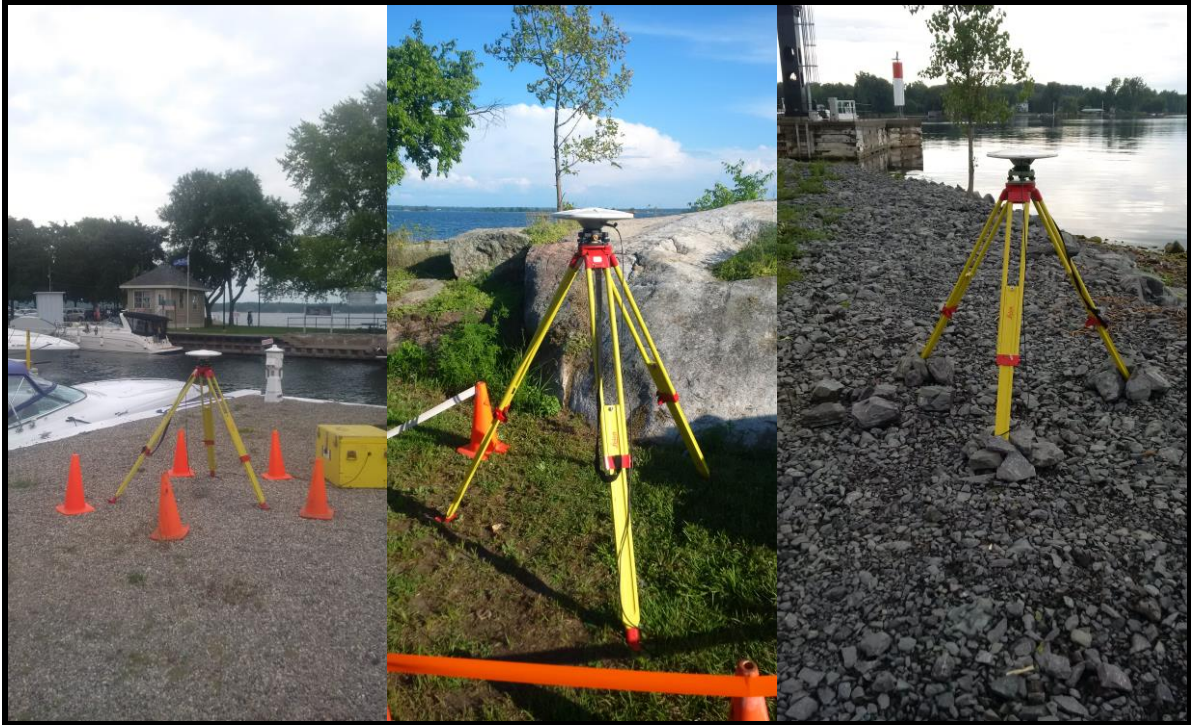
Figure 4 – Trimble R7, PPK GPS Reference Stations; Left to Right: Station TALL (Brockville), Station TINP (Mallorytown) and Station HIFD (Howe Island Ferry Dock)

LAND BASED COMPONENT	HYDROGRAPHIC EQUIPMENT
PPK GNSS – Base Stations (see Horizontal Control Section) Virtual PPK Base Stations	<ul style="list-style-type: none"> • Trimble R7 GNSS Receivers with Zephyr II, Geodetic antennae.

An attempt was made to utilize some existing survey benchmarks; however, temporary locations were used instead for various reasons. For station TALL, the nearest benchmark was elevated and in a high traffic area. The benchmark in the vicinity of station PRES was paved over at the Canadian Coast Guard Prescott base. For TINP, the location in the database was incorrect, placing the benchmark location within the river, it could not be found. No benchmark existed in the prime location needed for HIFD. Temporary control station markers were established at Tall Ships Marina in Brockville, at Prescott on the Canadian Coast Guard's base, Thousand Islands National Park in Mallorytown and on the Howe Island Ferry Dock just north of Howe Island on the mainland.

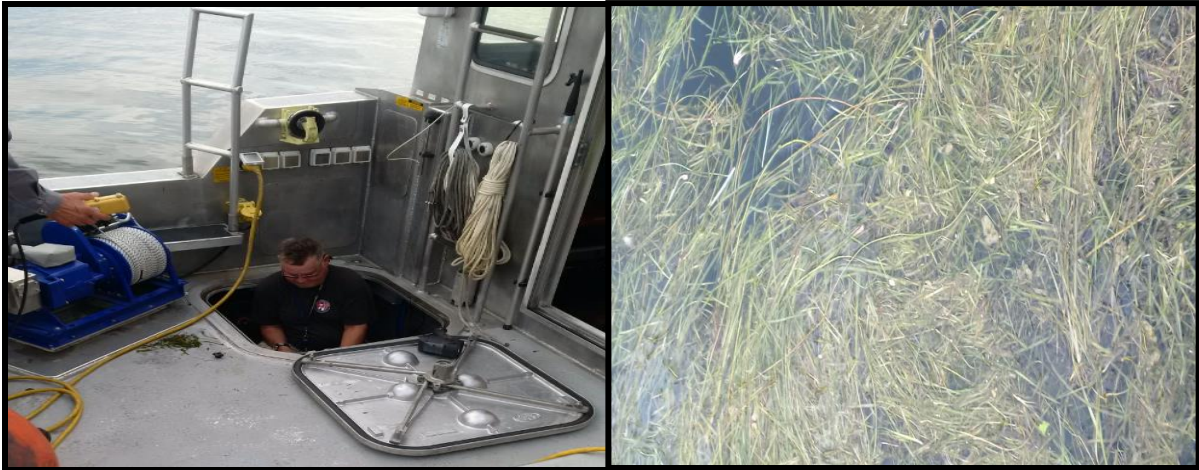
Figure 11 – Left; Logan cleaning out kelp/grass clogging the intake. An ongoing nuisance

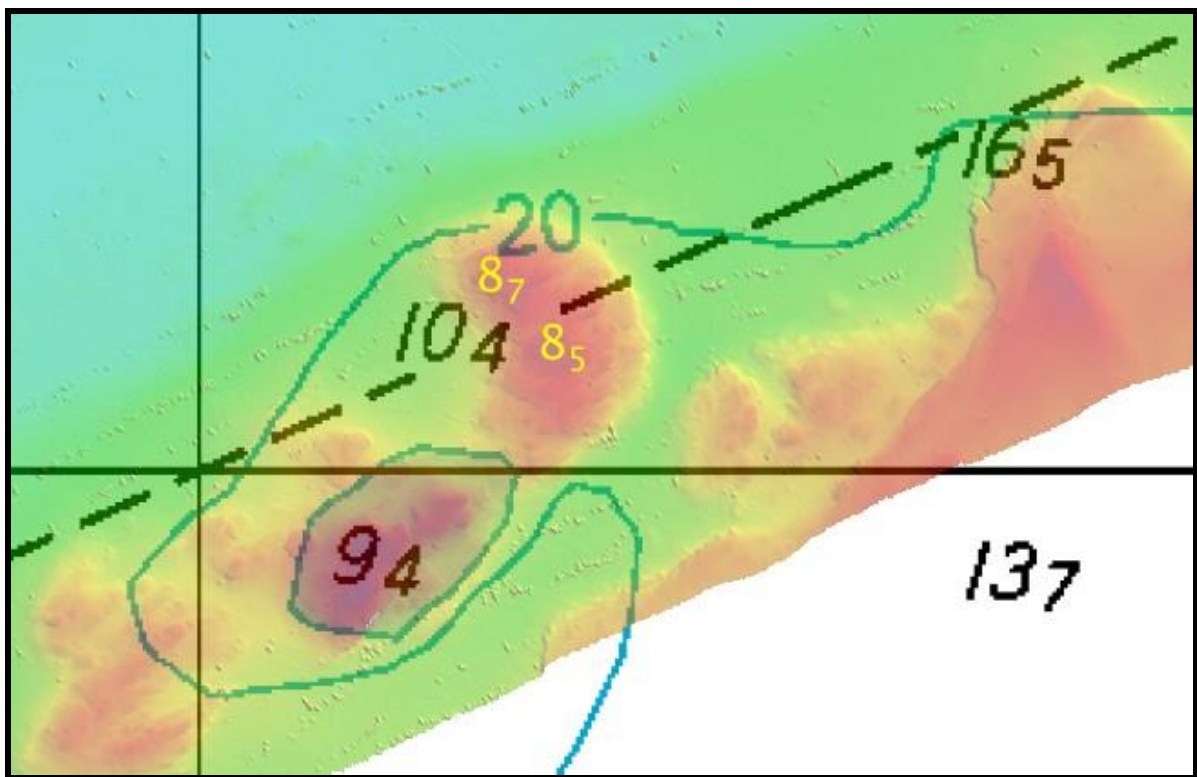
Figure 14 – NTS C2103/18 revealing dangerous depths shoaler than charted values on chart 1438. On October 5, 2018, the Notice to Shipping had been cancelled and replaced by Notice to Mariners 6604443.

18 August- Sunny, clear skies, winds coming out of north-east at 13kts with gusts to 18kts, *Bockmaster* to fuel up at Brennan Marine, Town of Gananoque assisted with Swing Bridge. *Bockmaster* continued survey of Kingston block. Di Franco Notice to Shipping (NTS) quality control revealed dangerous depths shoaler then charted values on 1438. C2103/18 was issued though the Marine Communications and Traffic Services. (See figure-14 pg.18)

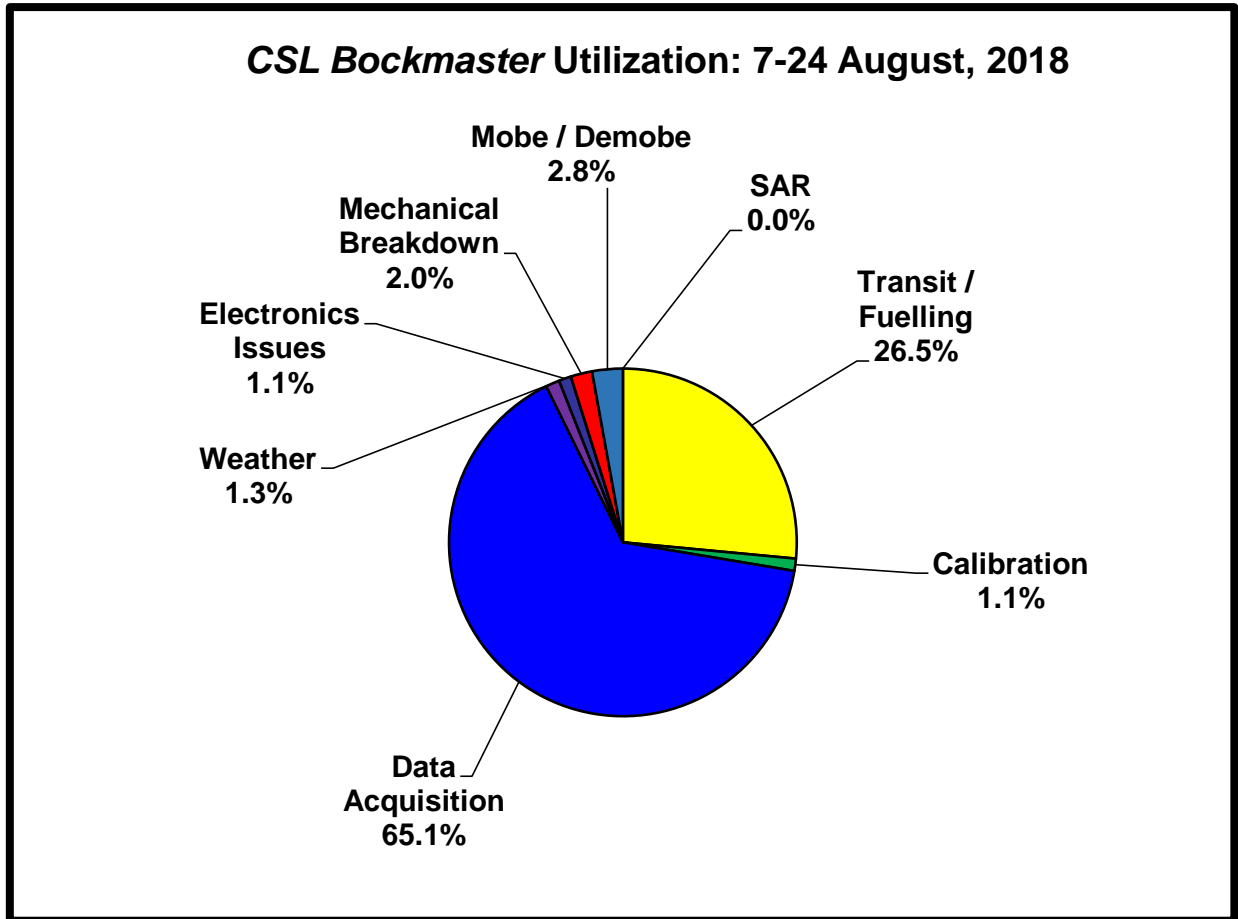
Figure 15: Vessel Time Utilization
